# PROPERTY INSPECTION REPORT

**FOUR POINT**  
HOME INSPECTION INC.

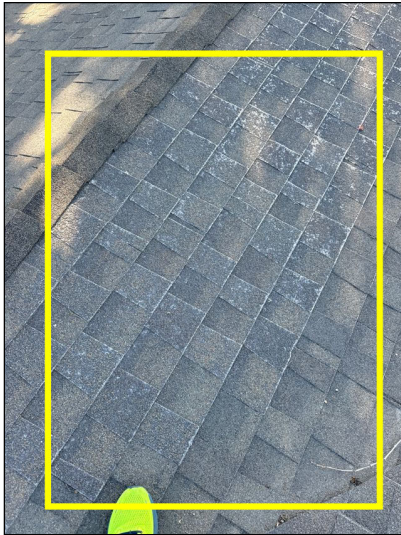
The asphalt composition shingles covering the roof of this home showed moderate deterioration that appeared to be commensurate with the age of the roof.

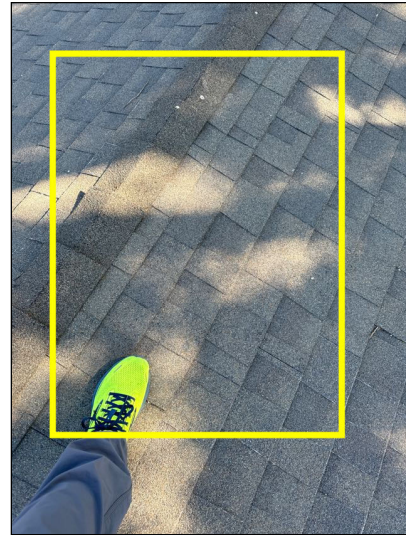
The asphalt composition shingles covering the roof of this home showed moderate deterioration that appeared to be commensurate with the age of the roof.

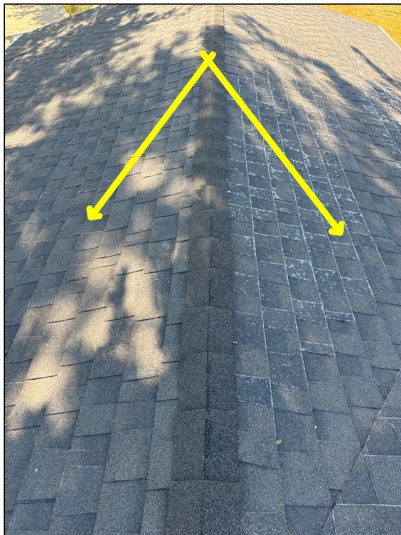
**Monitor:** Asphalt shingles covering some roof slopes exhibited severe deterioration and appeared to be at or near the end of their long-term service lives.

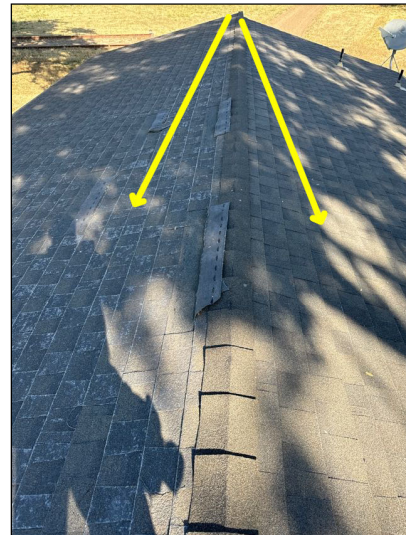
**Monitor:** Asphalt shingles covering some roof slopes exhibited severe deterioration and appeared to be at or near the end of their long-term service lives.

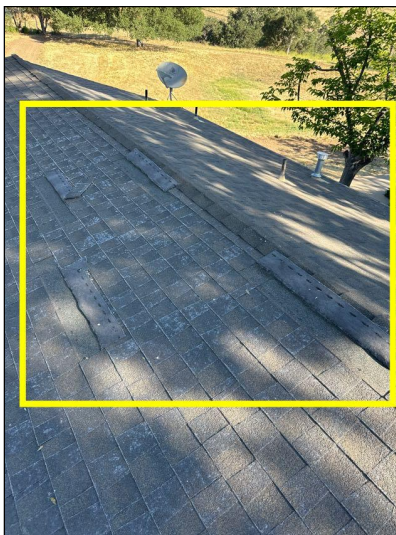
The roof had loose and/or missing shingles.

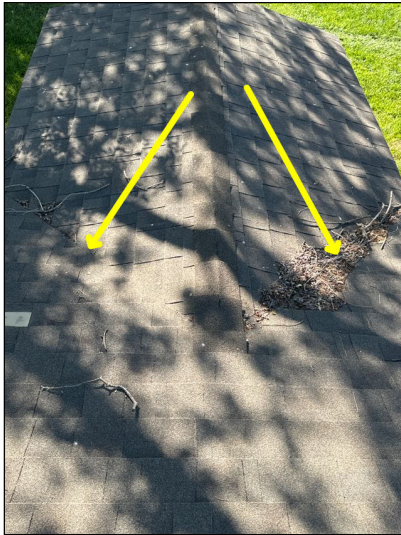
**Maintenance Needed:** Debris visible in the valley flashing at the time of the inspection should be removed to encourage proper drainage.

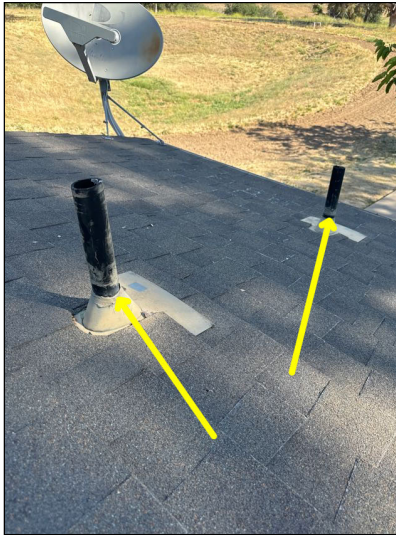
**Maintenance Needed:** Plumbing vent flashings are mastic covered and some are showing signs of cracked mastic/mastic deterioration from sun exposure.

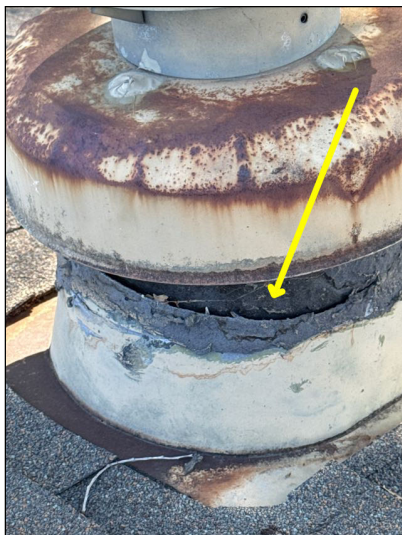
**Maintenance Needed:** Combustion vent flashings are mastic covered and some are *showing signs of cracked mastic/mastic deterioration* from sun exposure.

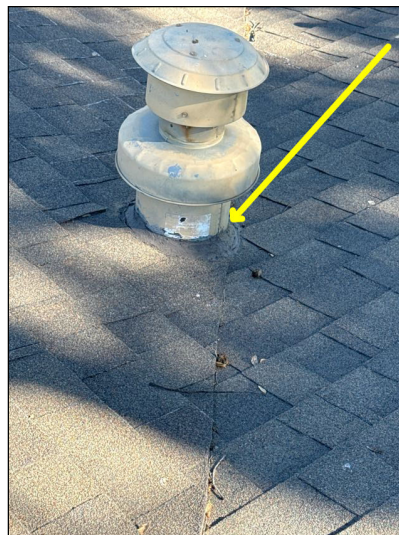
A combustion vent was installed in a valley.

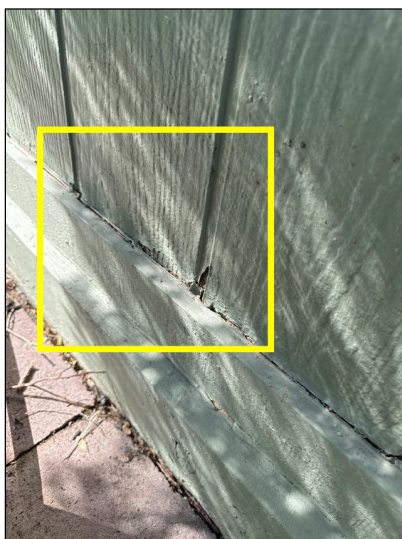
Moisture damage, wood rot, observed.

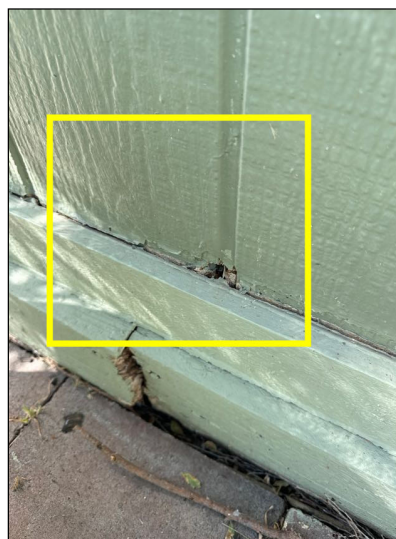
Moisture damage, wood rot, observed.

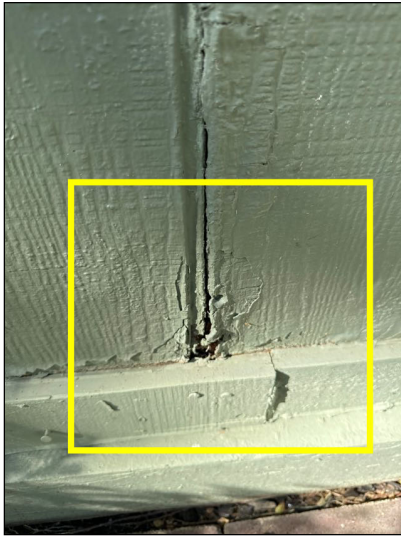
Moisture damage, wood rot, observed.

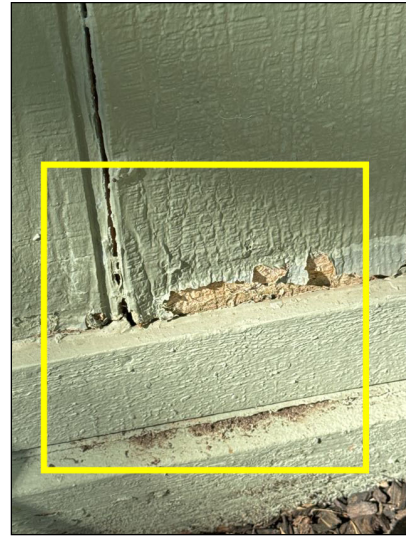
Moisture damage, wood rot, observed.

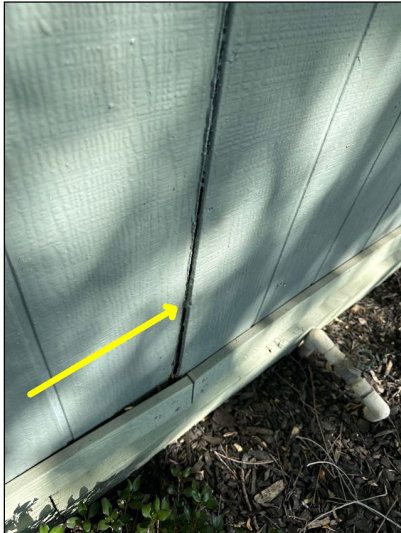
***Routine Maintenance:*** Gaps at joints of the siding more than 1/4 inch (ca. 10 cm) should be sealed to keep unwanted moisture out. Recommend having joints sealed and painted. Continue to monitored as part of annual maintenance.

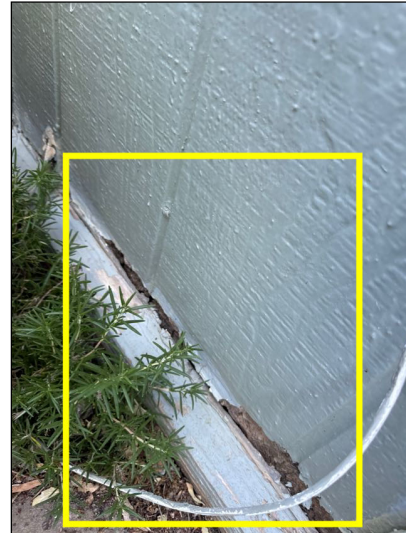
Moisture damage, wood rot, observed.

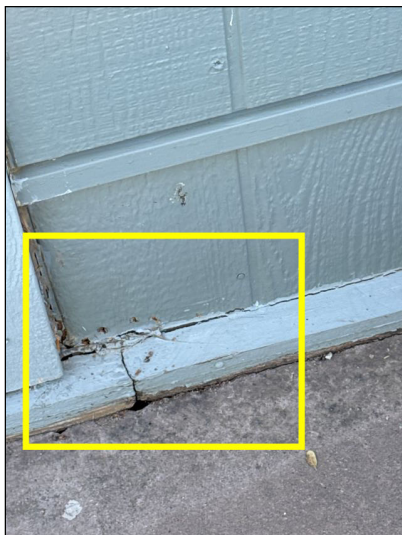
Moisture damage, wood rot, observed.

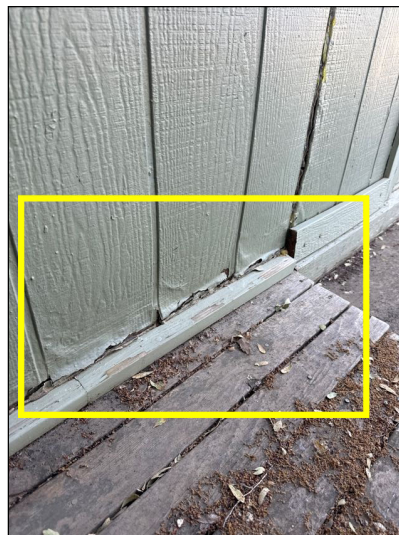
Moisture damage, wood rot, observed.

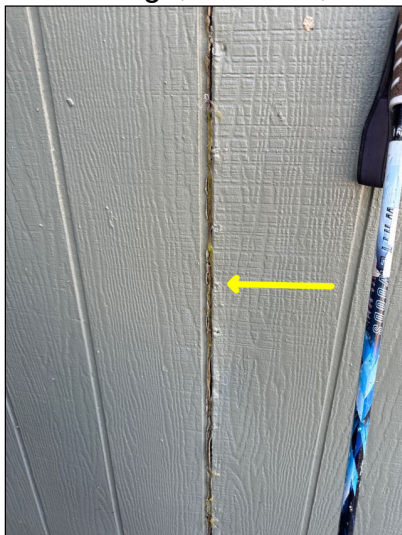
**Routine Maintenance:** Gaps at joints of the siding more than 1/4 inch (ca. 10 cm) should be sealed to keep unwanted moisture out. Recommend having joints sealed and painted. Continue to monitored as part of annual maintenance.

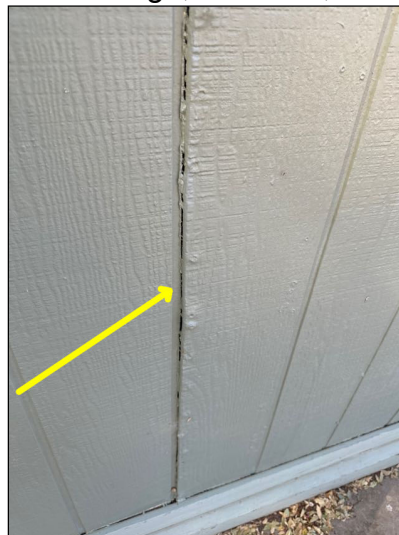
**Routine Maintenance:** Gaps at joints of the siding more than 1/4 inch (ca. 10 cm) should be sealed to keep unwanted moisture out. Recommend having joints sealed and painted. Continue to monitored as part of annual maintenance.

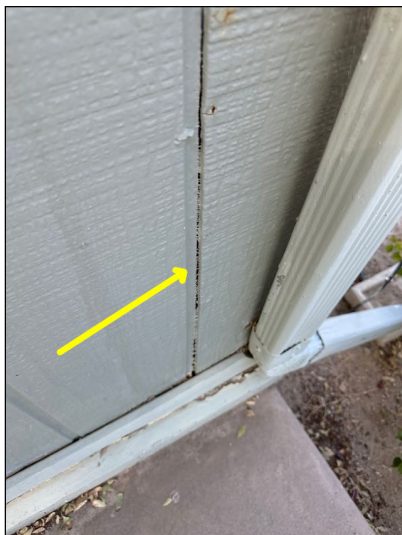
**Routine Maintenance:** Gaps at joints of the siding more than 1/4 inch (ca. 10 cm) should be sealed to keep unwanted moisture out. Recommend having joints sealed and painted. Continue to monitored as part of annual maintenance.

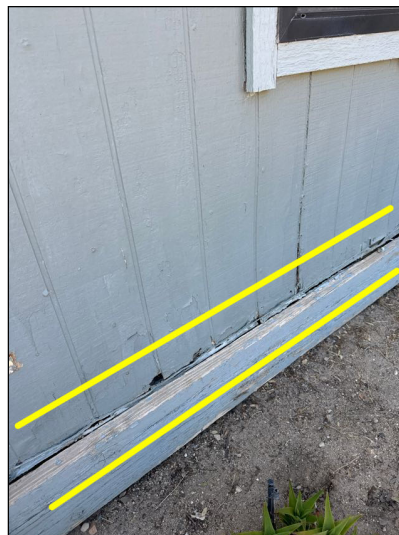
Moisture damage, wood rot, observed.

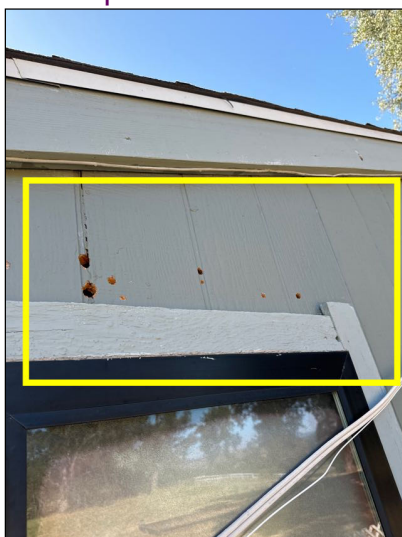
Bird damage to wood siding covering exterior walls of the home was visible at the time of the inspection.

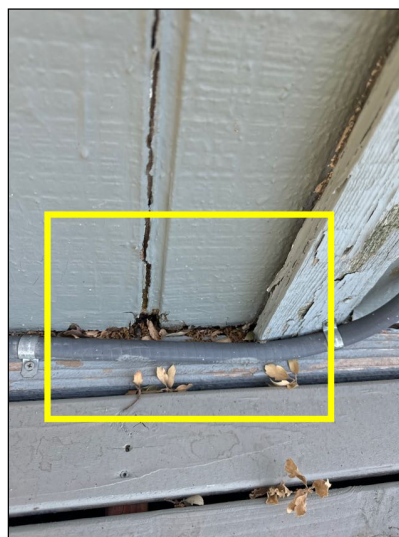
Moisture damage, wood rot, observed.

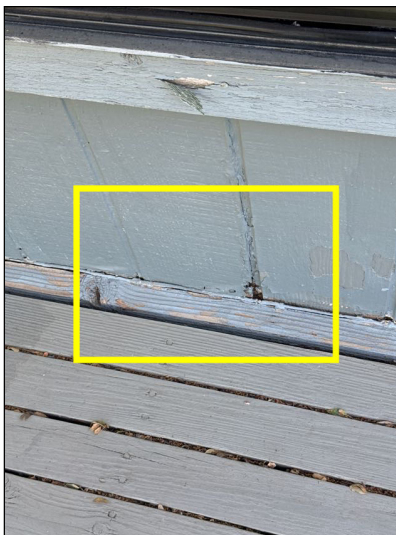
Moisture damage, wood rot, observed.

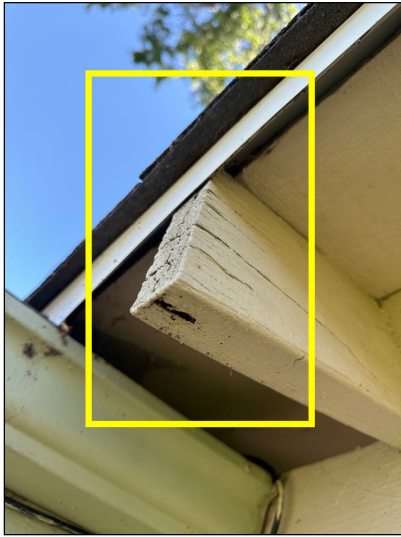
Moisture damage, wood rot, observed.

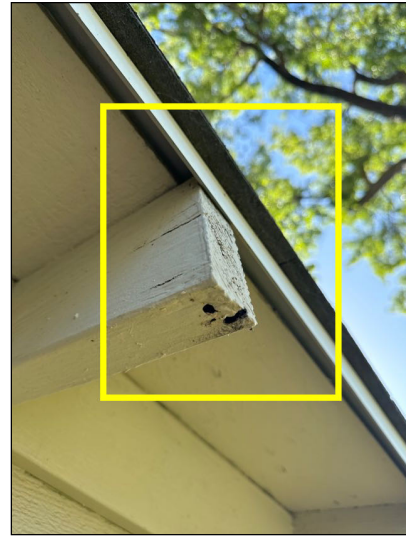
Moisture damage, wood rot, observed.

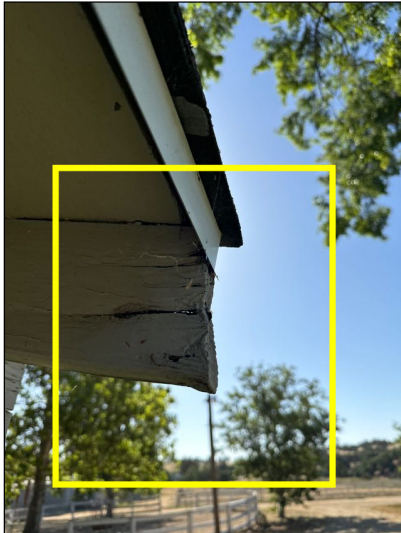
Moisture damage, wood rot, observed.

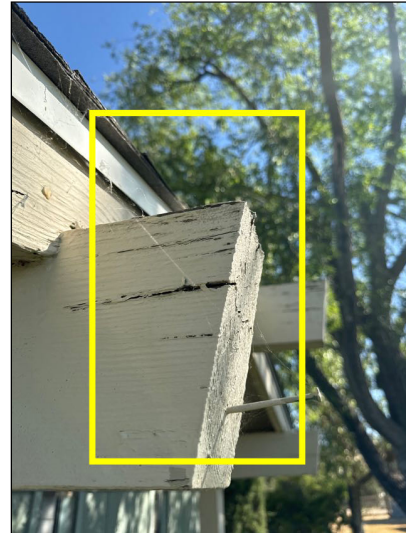
Moisture damage, wood rot, observed.

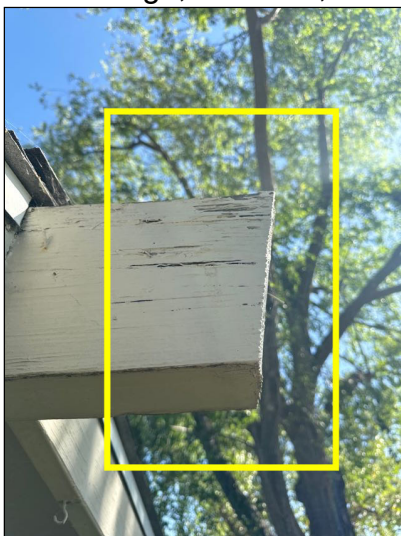
Moisture damage, wood rot, observed.

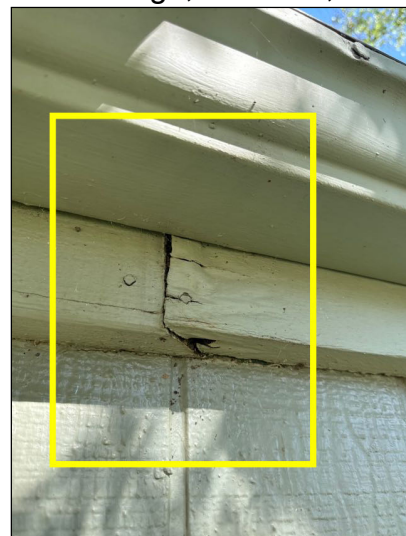
Moisture damage, wood rot, observed.

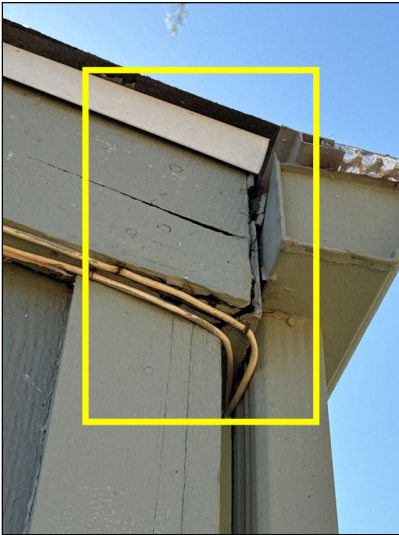
Moisture damage, wood rot, observed.

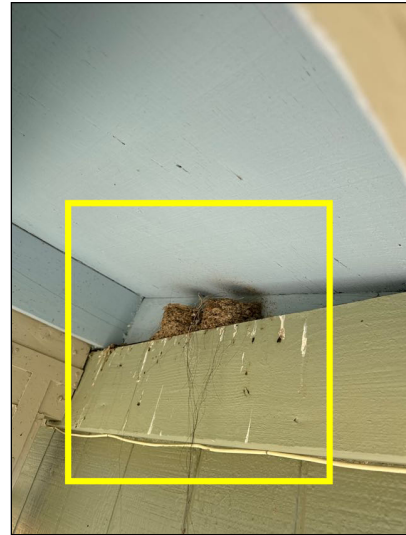
*Monitor:* Past Swallow nest evident under the soffits.

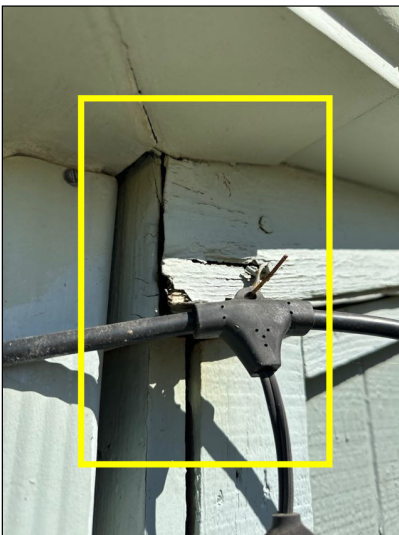
Moisture damage, wood rot, observed.

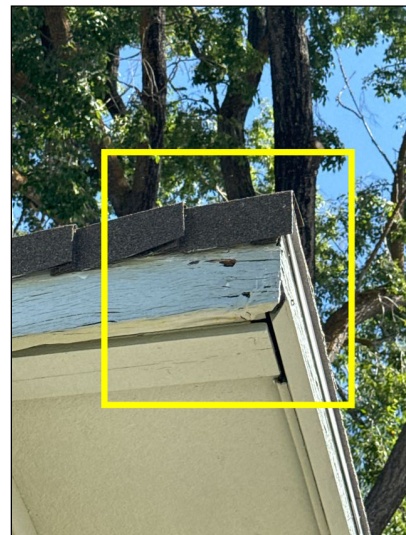
Moisture damage, wood rot, observed.

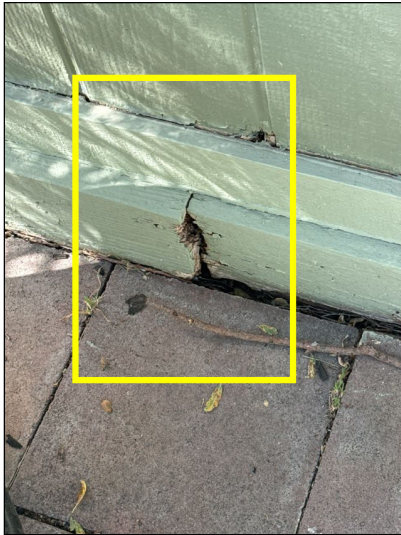
Moisture damage, wood rot, observed.

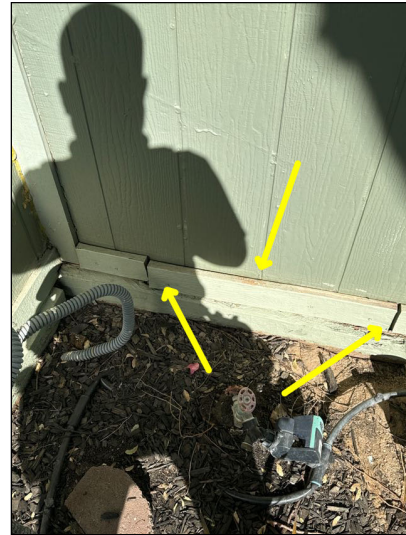
**Maintenance Needed:** Trim had gaps that should be filled with an appropriate sealant by a qualified contractor to help prevent moisture and insect entry.

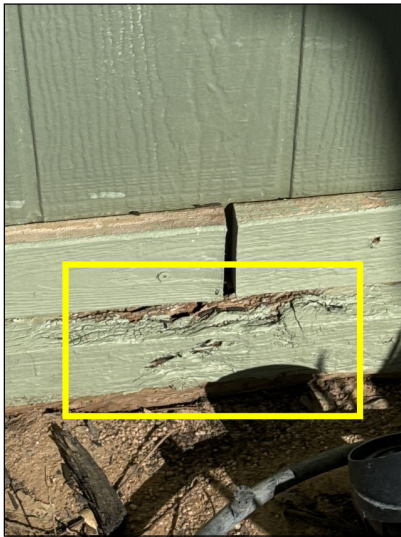
Moisture damage, wood rot, observed.

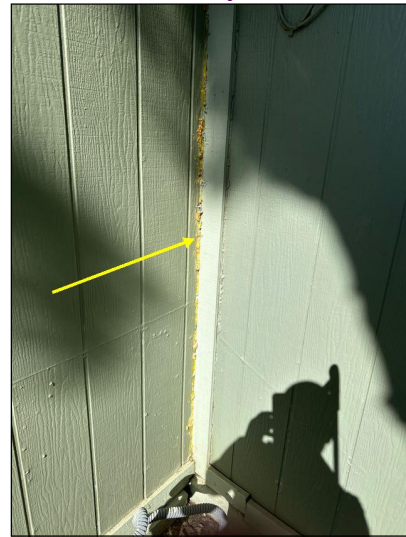
**Maintenance Needed:** Trim had gaps that should be filled with an appropriate sealant by a qualified contractor to help prevent moisture and insect entry.

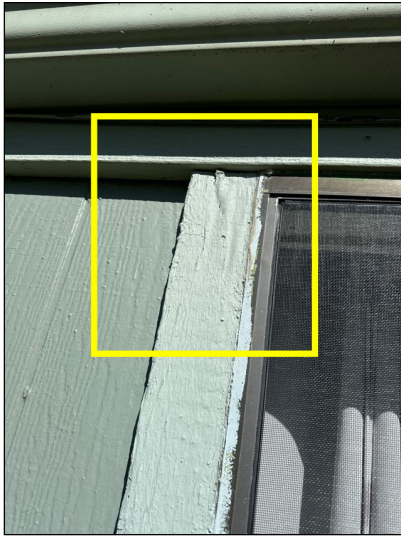
Moisture damage, wood rot, observed.

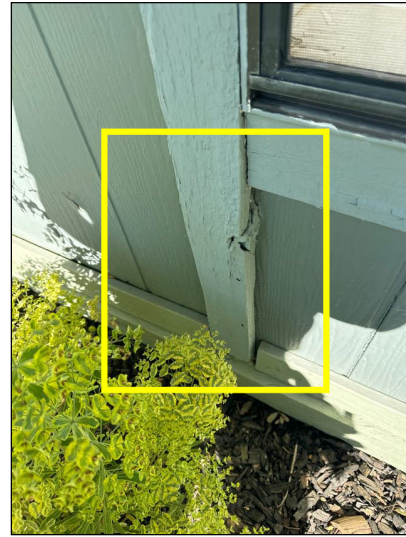
Moisture damage, wood rot, observed.

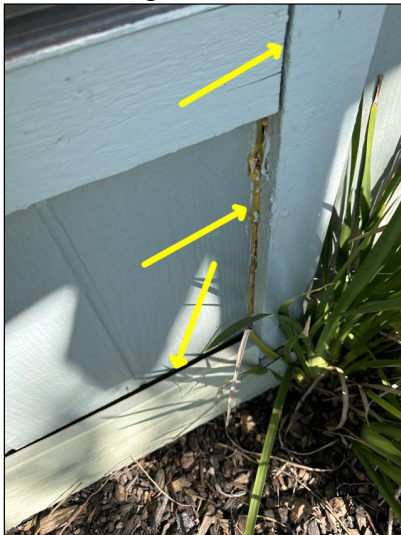
Moisture damage, wood rot, observed.

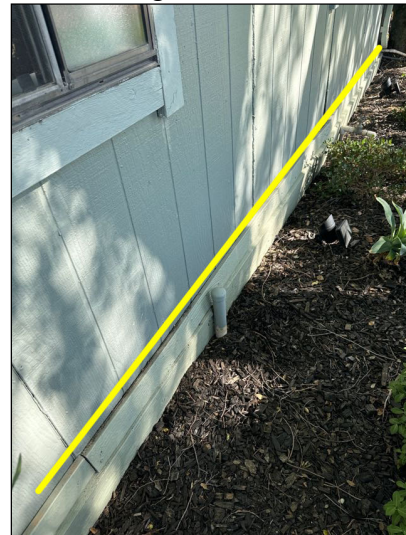
**Maintenance Needed:** Trim had gaps that should be filled with an appropriate sealant by a qualified contractor to help prevent moisture and insect entry.

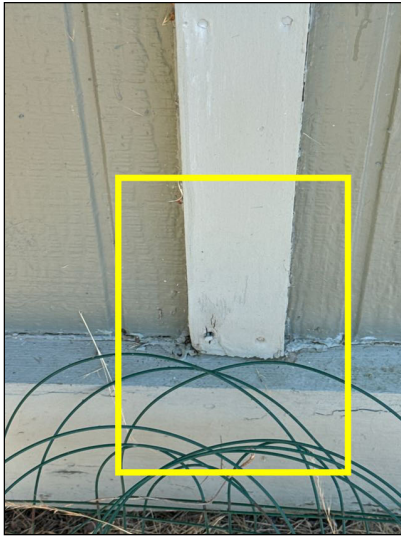
Moisture damage, wood rot, observed.

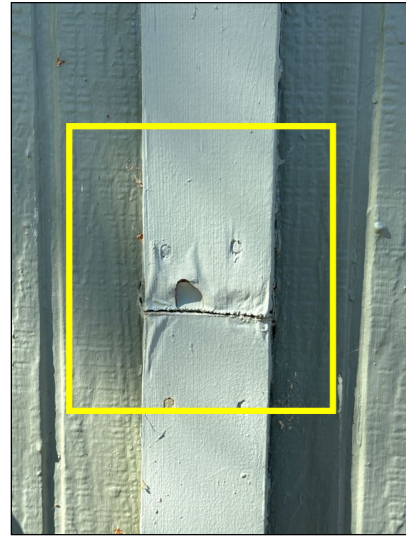
Moisture damage, wood rot, observed.

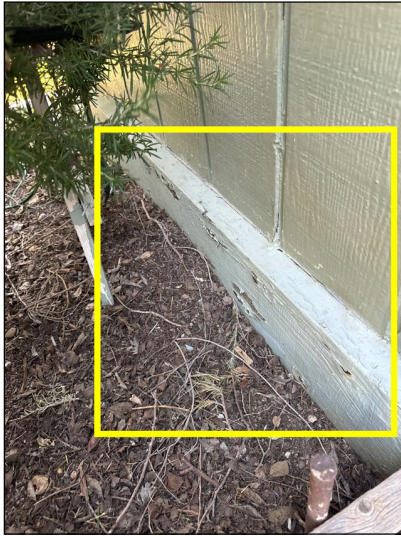
Moisture damage, wood rot, observed.

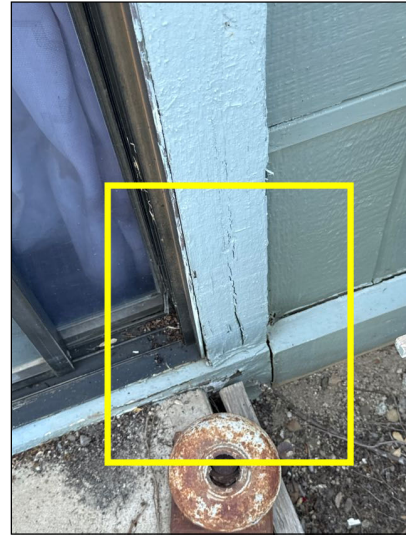
Moisture damage, wood rot, observed.

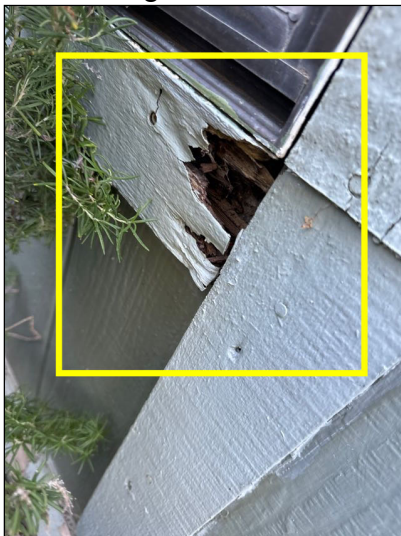
Moisture damage, wood rot, observed.

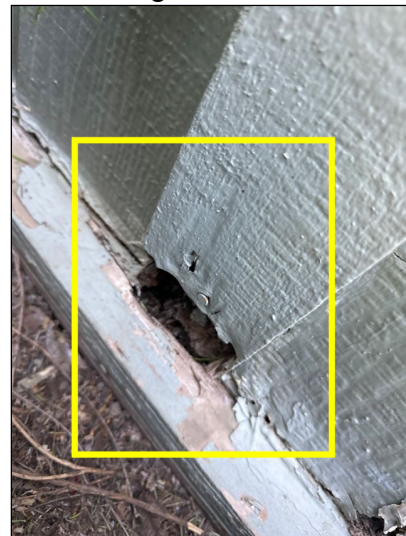
Moisture damage, wood rot, observed.

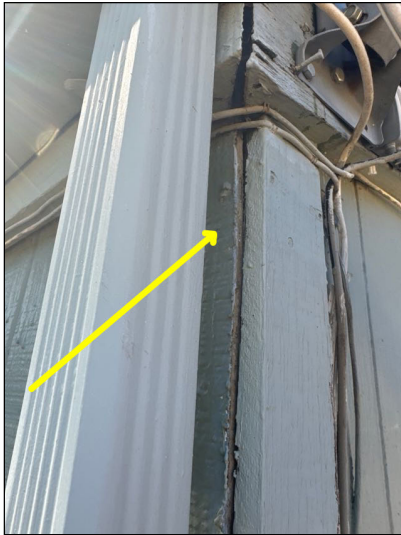
Missing trim should be replaced by a qualified contractor.

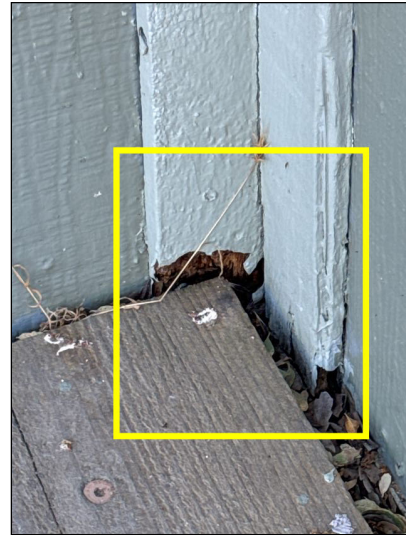
Moisture damage, wood rot, observed.

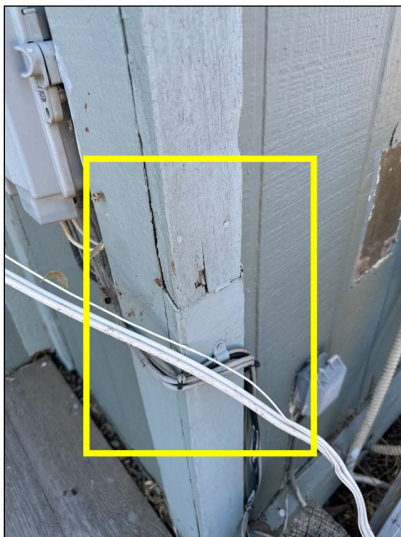
Moisture damage, wood rot, observed.

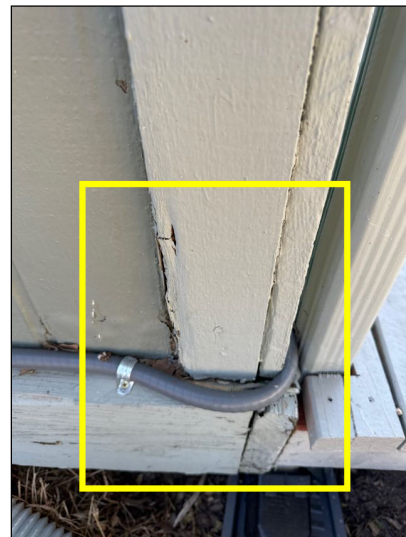
Moisture damage, wood rot, observed.

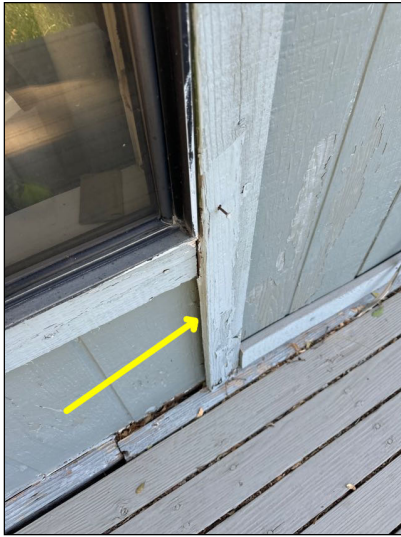
Trim loose at the time of the inspection should be re-fastened by a qualified contractor.

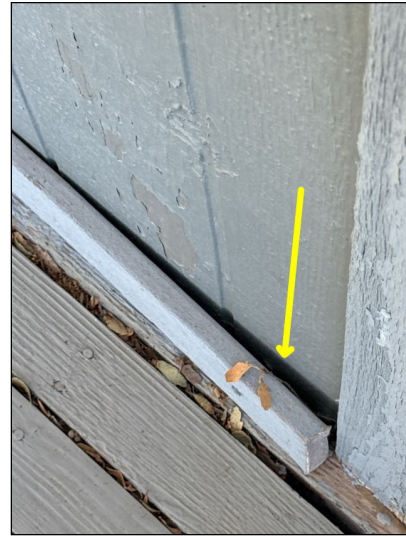
Trim loose at the time of the inspection should be re-fastened by a qualified contractor.

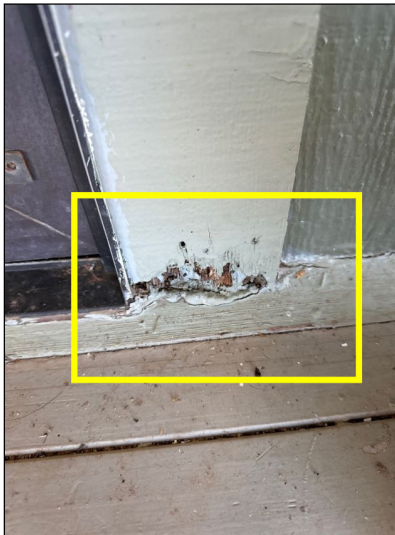
Moisture damage, wood rot, observed.

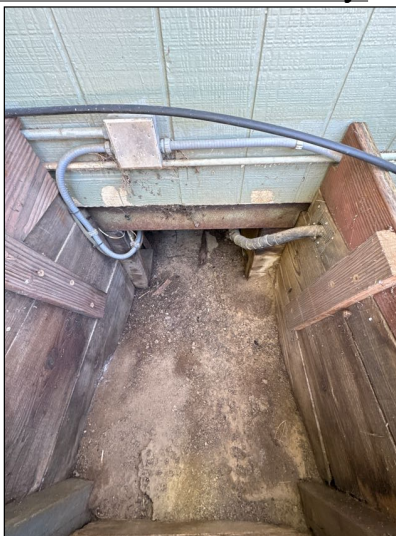
# Crawlspace Foundation (continued)

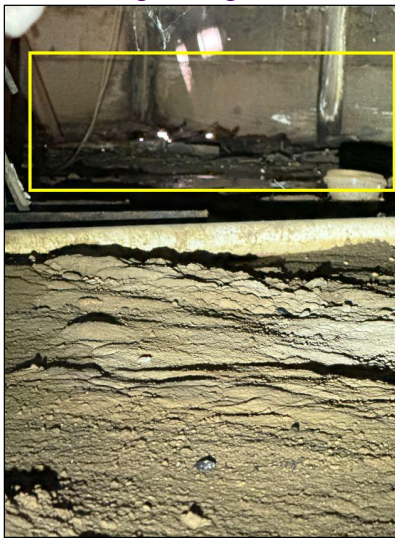
**Monitor:** Stains visible on the interior surfaces of the foundation walls/skirting in the crawlspace appeared to be the result of past moisture intrusion.

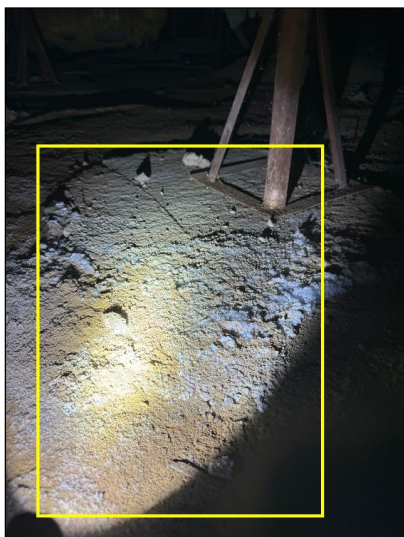
Soil in the crawlspace was visibly damp or wet.

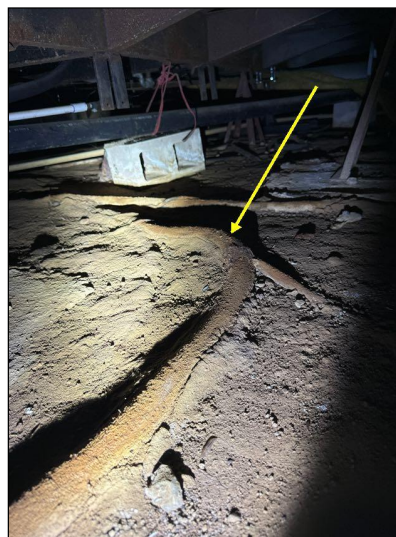
Tree roots growing under the home

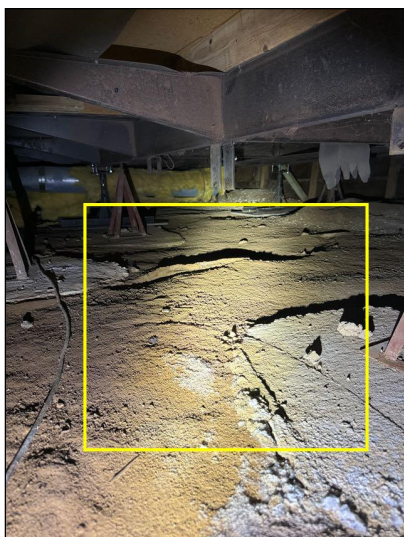
Soil in the crawlspace was visibly damp or wet.

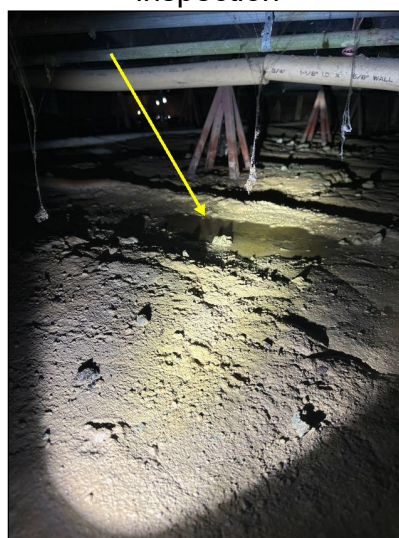
Water pooled in the crawlspace at the time of the inspection

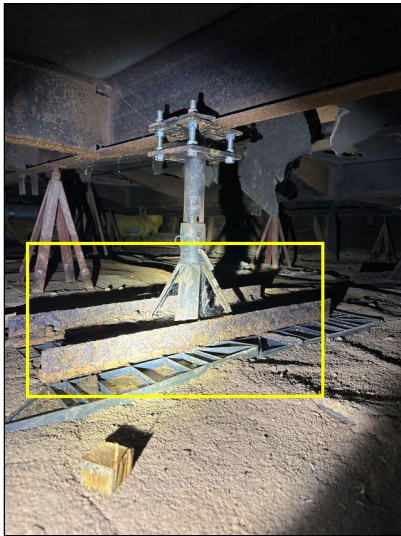
Steel beam girders supporting the floor structure in the crawlspace were supported by adjustable steel posts commonly called "screw jacks" on wood block.

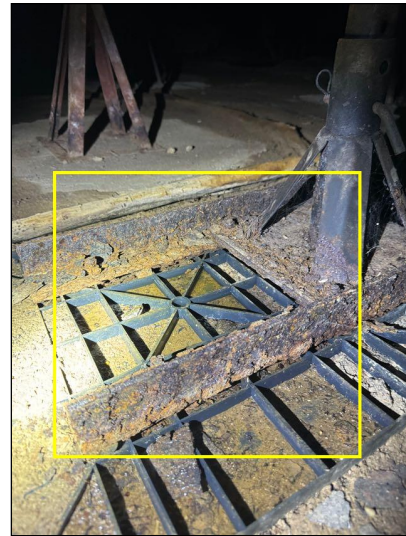
Steel beam girders supporting the floor structure in the crawlspace were supported by adjustable steel posts commonly called "screw jacks" on wood block.

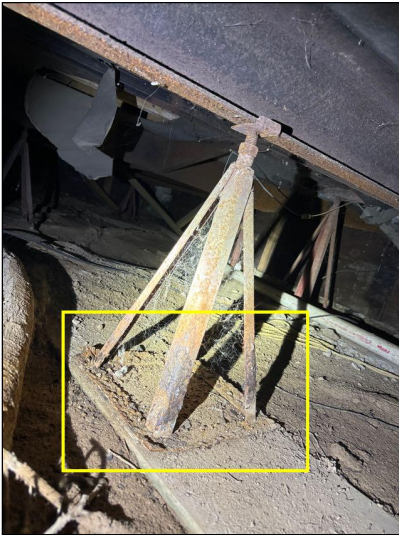
There are rusted or damaged screw jacks supporting the structure. Recommend jacks are replaced and annually inspected by a certified mobile home contractor.

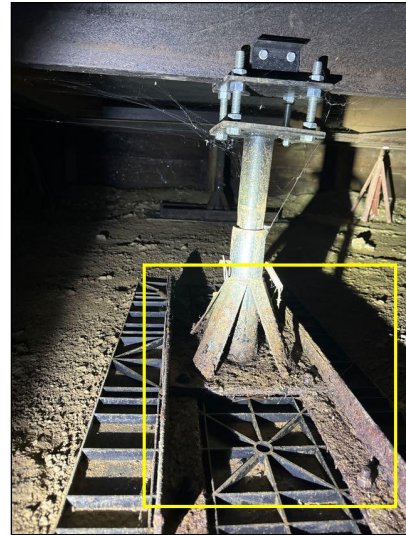
There are rusted or damaged anchor jacks supporting the structure. Recommend jacks are replaced and annually inspected by a certified mobile home contractor.

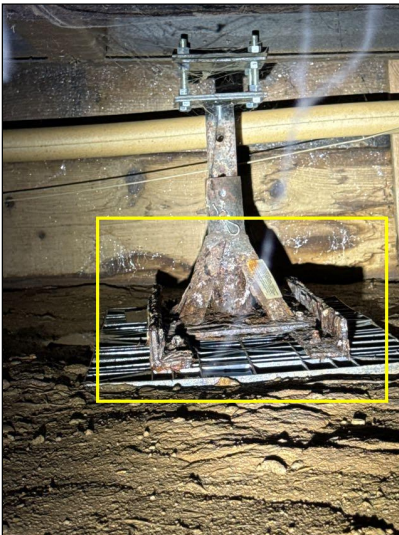
There are rusted or damaged anchor jacks supporting the structure. Recommend jacks are replaced and annually inspected by a certified mobile home contractor.

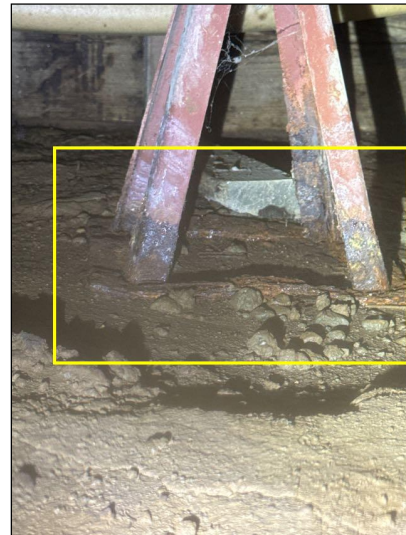
There are rusted or damaged screw jacks supporting the structure. Recommend jacks are replaced and annually inspected by a certified mobile home contractor.

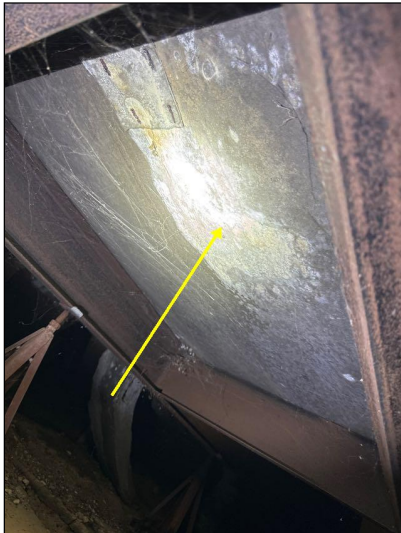
The sub floor had areas of localized advanced decay that appeared to be connected with plumbing fixture leakage.

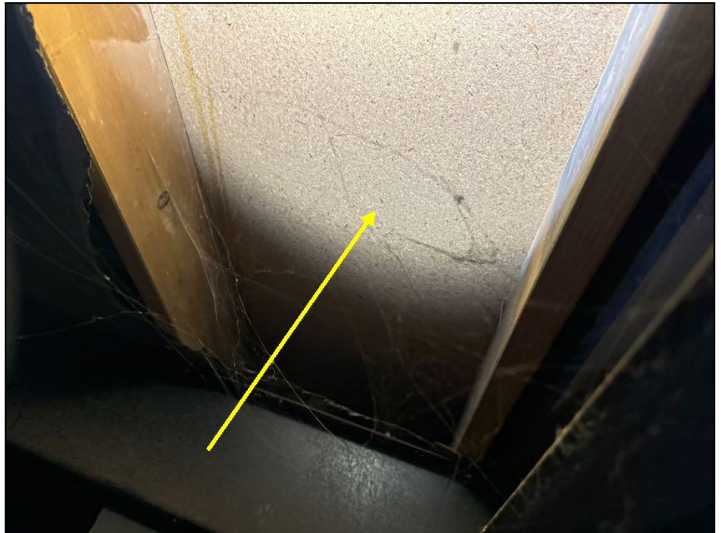
The floor structure consisted of particle board subfloor installed over conventional joists resting on the steel beam foundation.

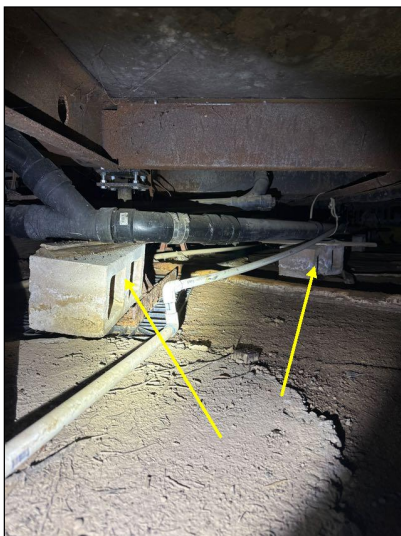
Plastic waste or drain pipes visible in the crawlspace were improperly supported.

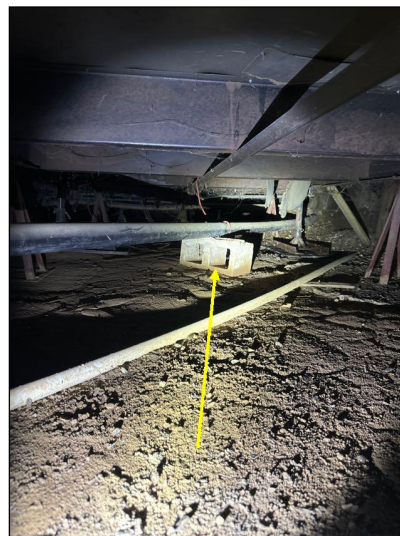
Plastic waste or drain pipes visible in the crawlspace were improperly supported.

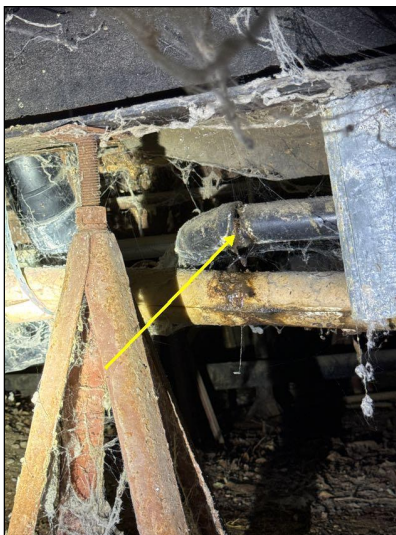
Leaking waste water pipes were visible in the crawlspace at the time of the inspection.

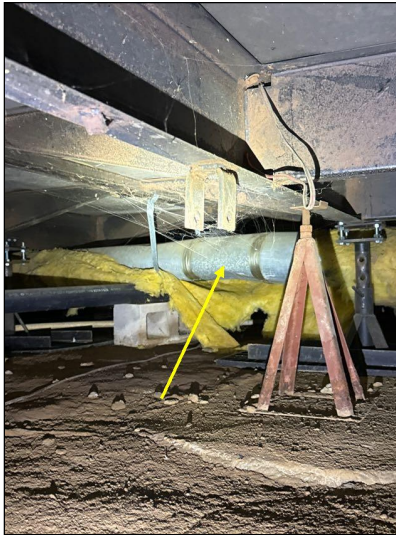
*Monitor:* Ducts were missing insulation in areas.

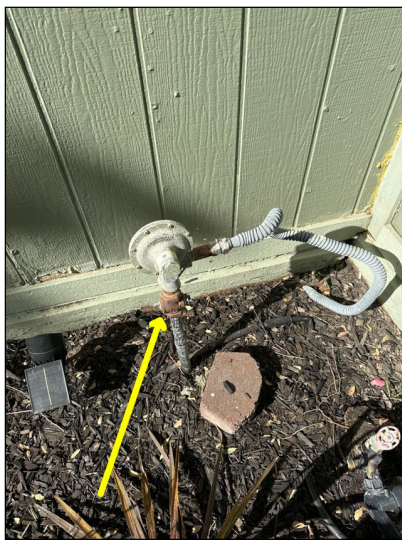
Main gas shut off to the home.

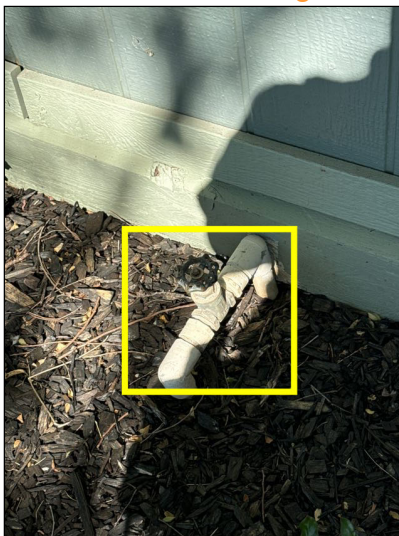
Main water shut off to the home where the main water line enters the home.

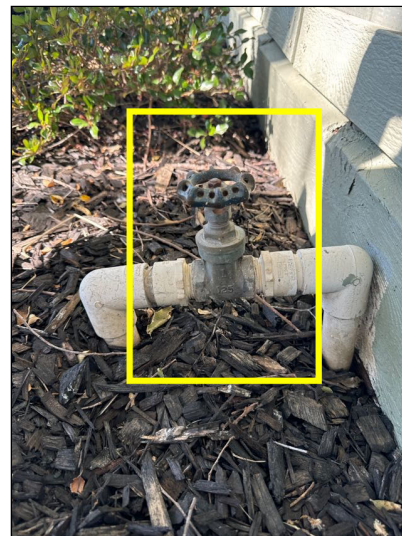
**Improvement:** Gate valve present as main water shut off, this type of valve has a history of failure with age.

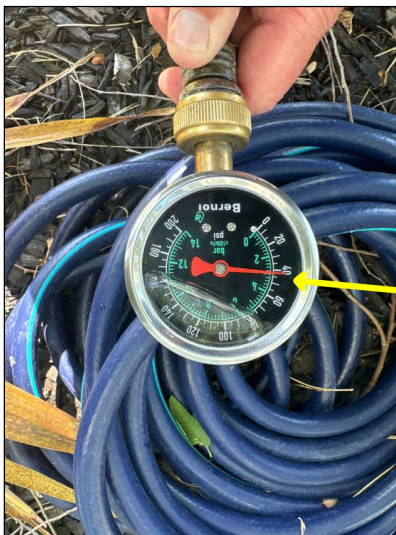
Home water pressure measured 45 pounds per square inch (psi) at the time of the inspection.

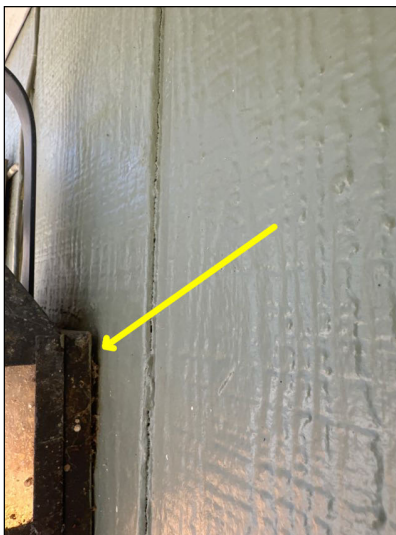
Exterior lighting was loose to the wall and could expose electrical components to moisture intrusion.

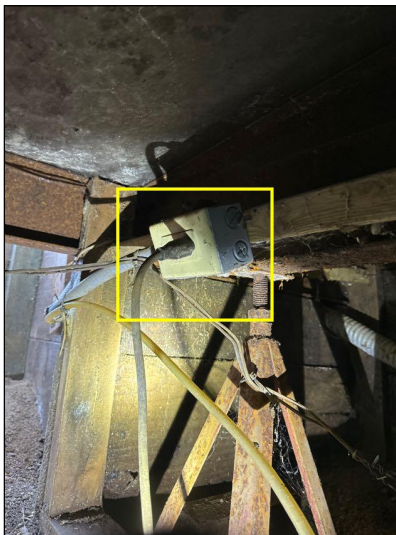
One exterior outlet under crawlspace at the home was not protected from weather.

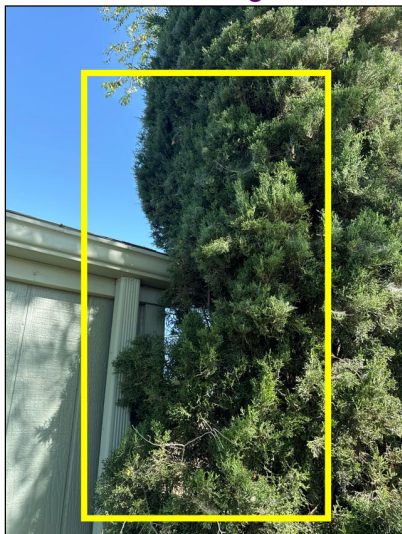
**Monitor:** Vegetation in contact with the exterior walls should be cut back to avoid potential problems from moisture or insects.

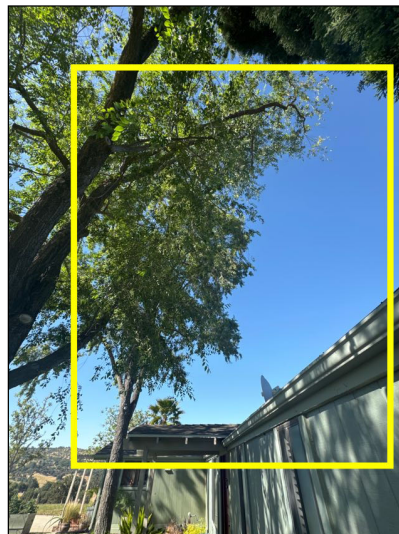
**Monitor:** Tree limbs within 10 feet of roof should be trimmed away to provide air and sunlight to roof, while minimizing debris & dampness.

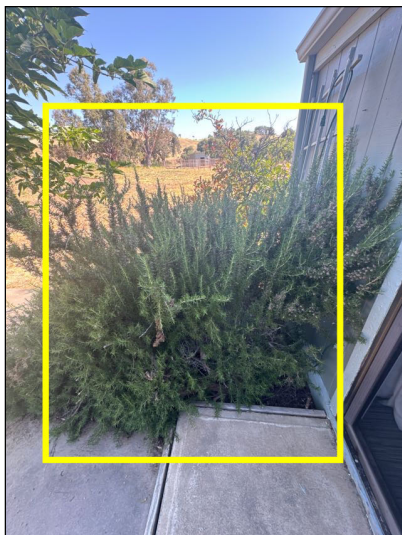
**Monitor.** Vegetation in contact with the exterior walls should be cut back to avoid potential problems from moisture or insects.

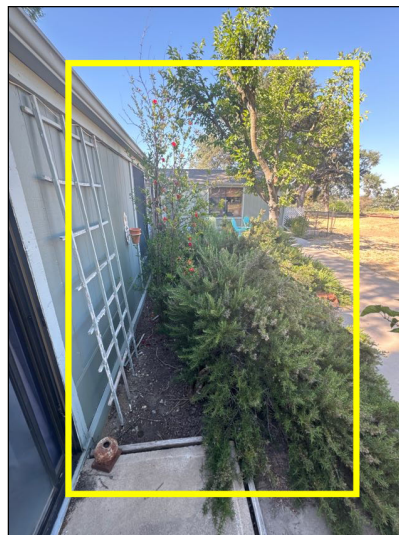
**Monitor.** Vegetation in contact with the exterior walls should be cut back to avoid potential problems from moisture or insects.

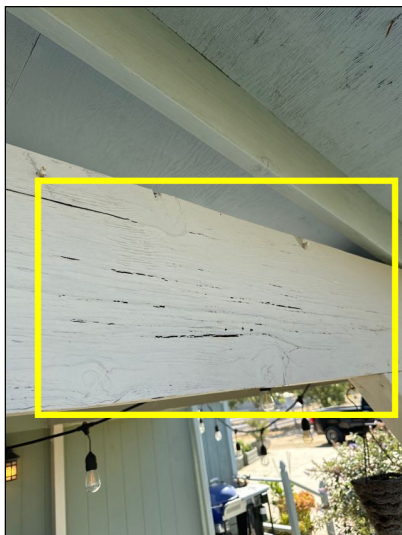
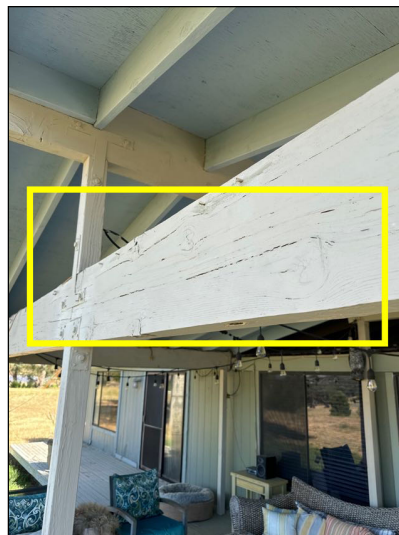
Dry-rot or fungus damage. Refer to pest report for further details and repair damage as needed.

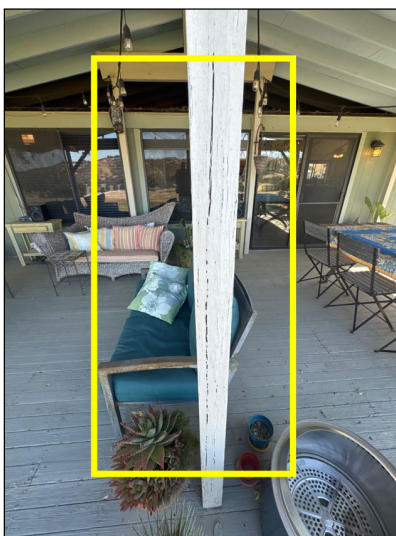
One or more wood post(s) supporting the patio cover/roof structure had wood decay visible at the time of the inspection. Unless this condition is corrected, it will eventually compromise the ability of the post to support the weight of the structure above. Corrections should be made by a qualified contractor.

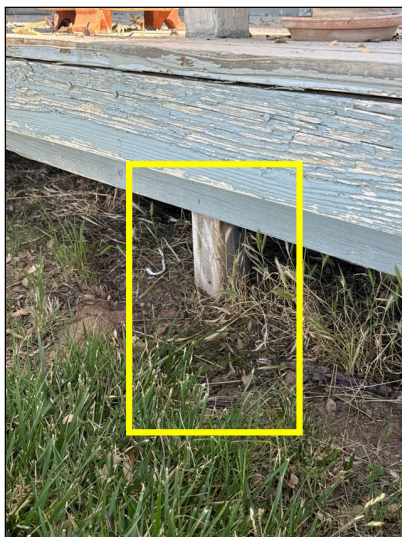
One or more posts supporting the deck had contact with soil at the time of the inspection.

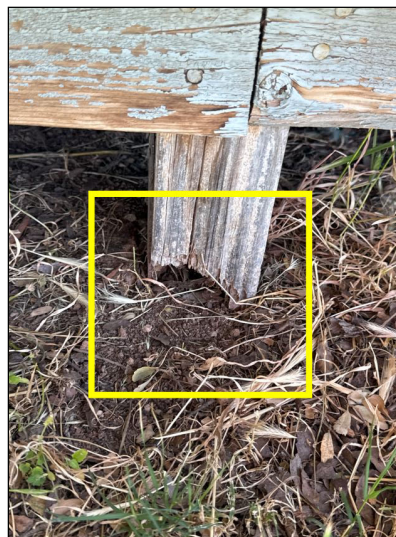
Foundation piers supporting the porch appeared to be unstable at the time of the inspection.

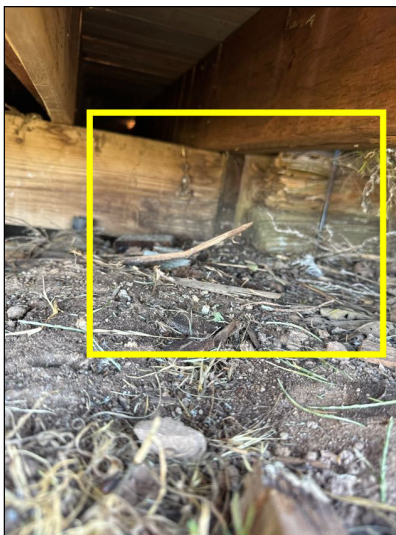
One or more posts supporting the deck had contact with soil at the time of the inspection.

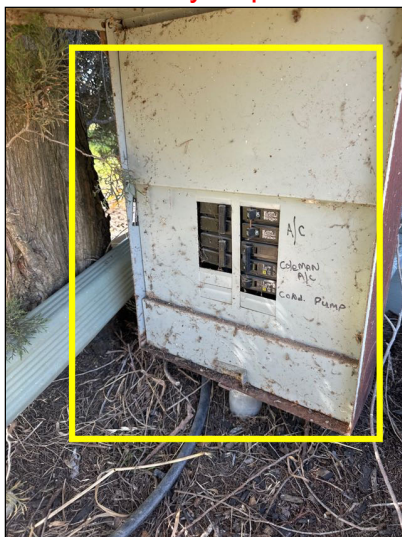
Main electrical service panel to the home.

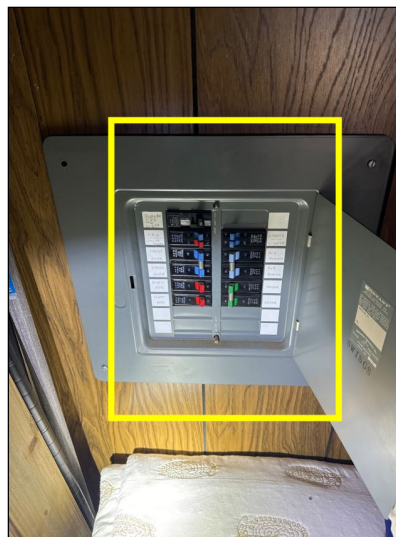
Sub panel to the home

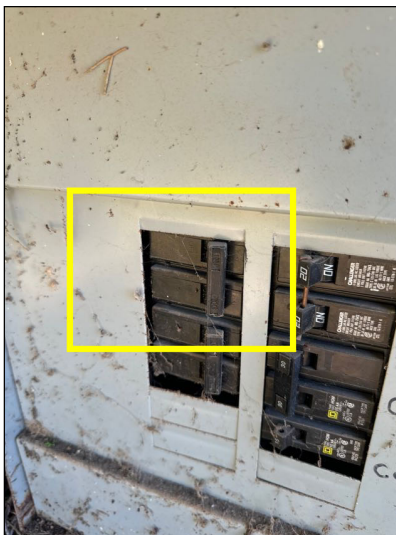
Main electrical shut off to the home

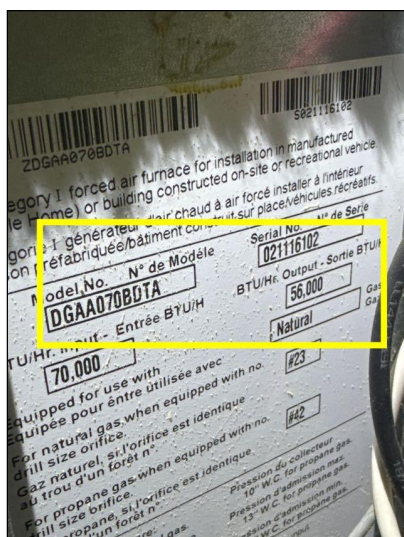
Heater model and serial number Unit 1

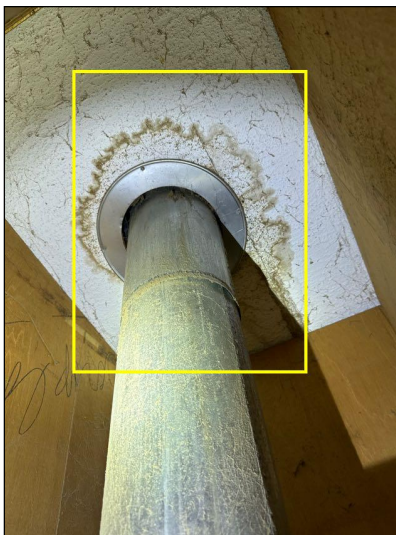
**Monitor:** Stains on the interior of the water heater enclosure visible at the time of the inspection appeared to be the result of moisture intrusion. Unit 2

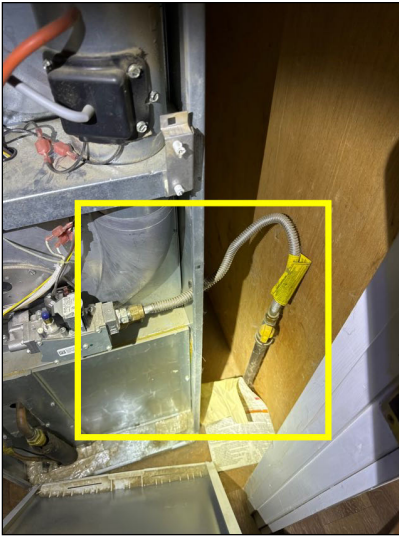
**Improvement:** The gas supply pipe contained no sediment trap.

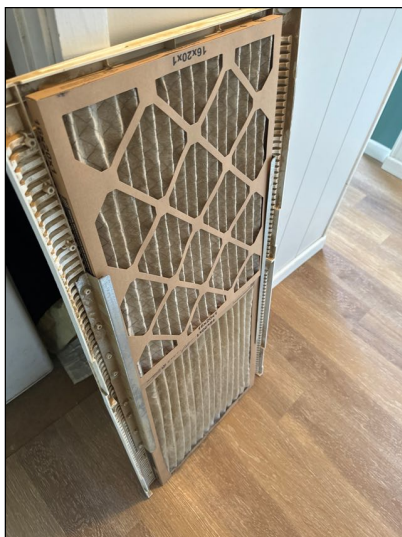
The air filter for this furnace was dirty and should be changed.
