# PROPERTY INSPECTION REPORT

**FOUR POINT**  
HOME INSPECTION INC.

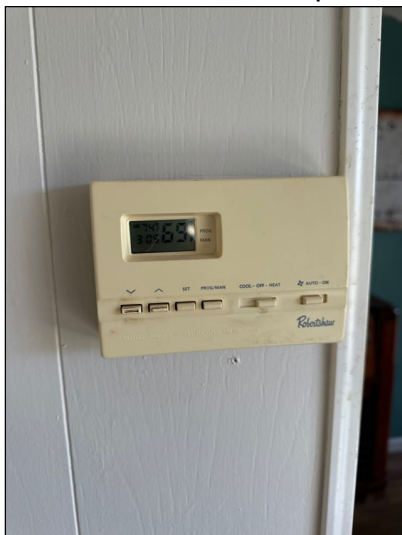
Digital - programmable type.

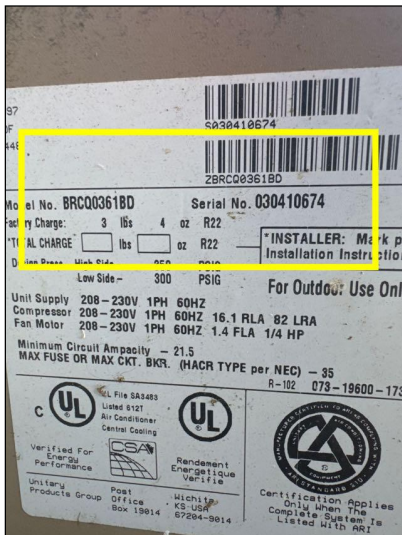
AC model and serial number Unit 1

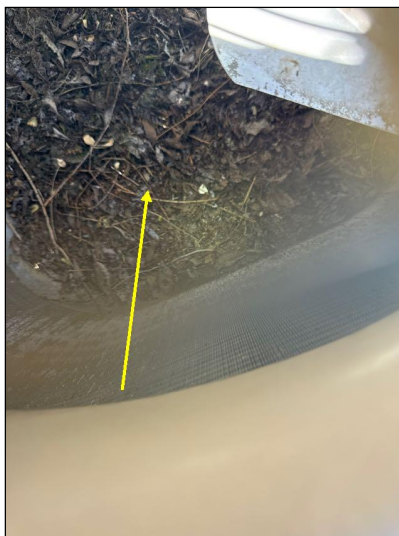
**Monitor:** The air-conditioner condenser unit had visible moderate of debris inside the cabinet.

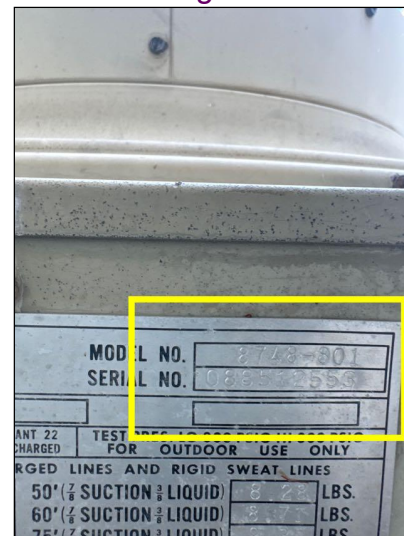
AC model and serial number Unit 2

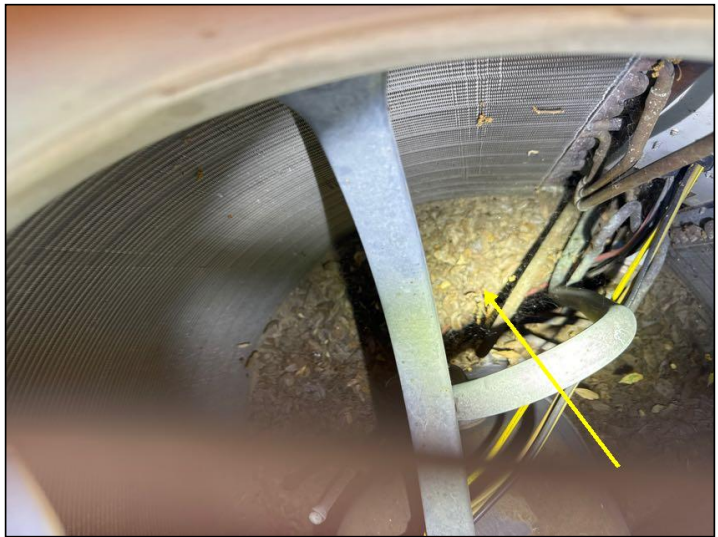
**Monitor:** The air-conditioner condenser unit had visible moderate of debris inside the cabinet.

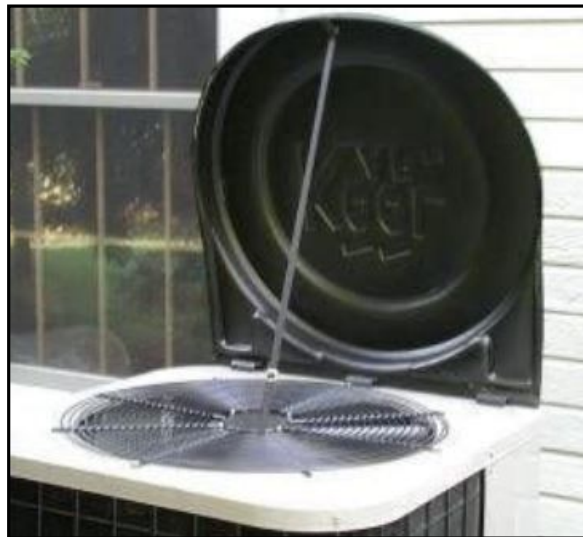
**Improvement:** The inspectors recommends that an approved condenser cap be added to the A/C unit to protect the unit from collecting debris.

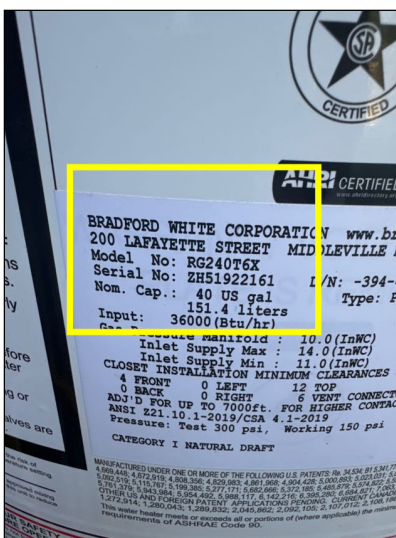
Water heater model and serial number

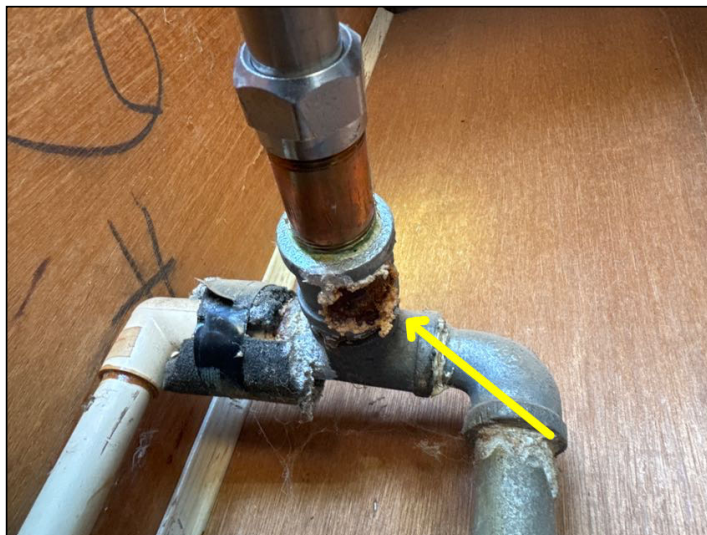
*Monitor:* Corrosion observed, no leaks detected at the time of inspection.

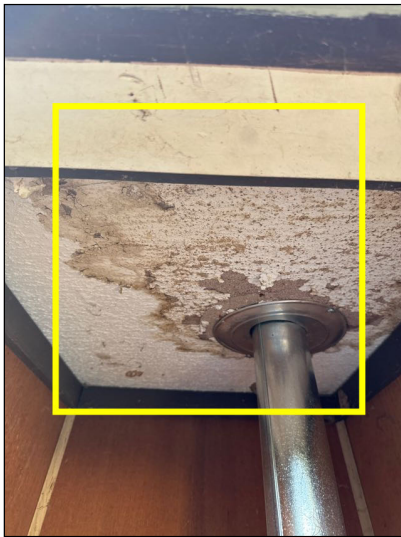
*Monitor:* Stains on the interior of the water heater enclosure visible at the time of the inspection appeared to be the result of moisture intrusion.

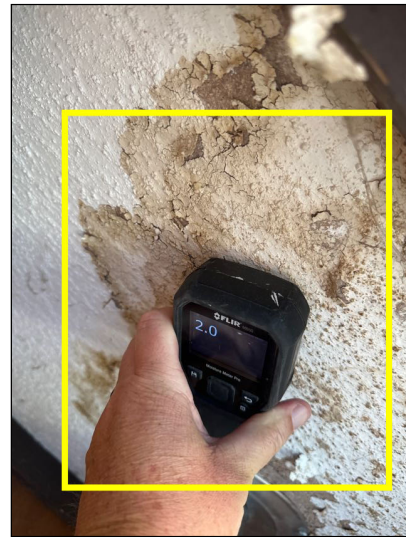
The moisture meter showed no elevated levels of moisture present in the stained areas (Normal moisture is considered between 5-12%)

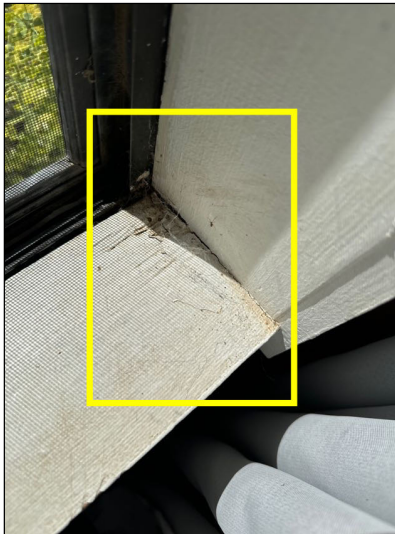
Windows sills in the home exhibited minor damage that appeared to be from moisture intrusion.

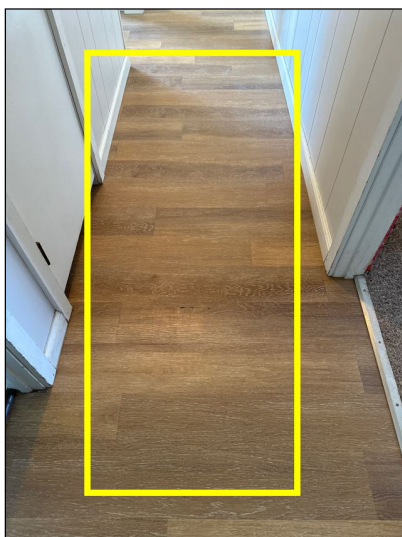
**Monitor:** The home had area(s) of uneven floor that may be caused by settlement or damaged sub flooring.

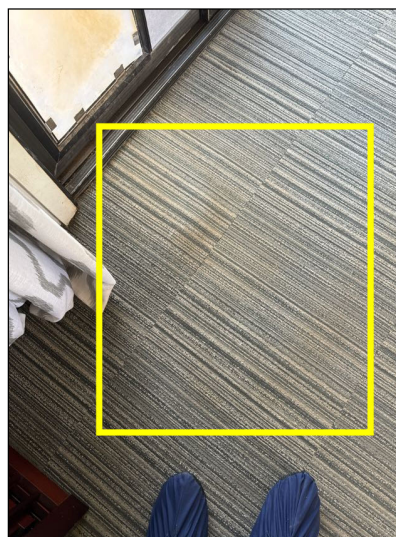
**Monitor:** The home had area(s) of uneven floor that may be caused by settlement or damaged sub flooring.

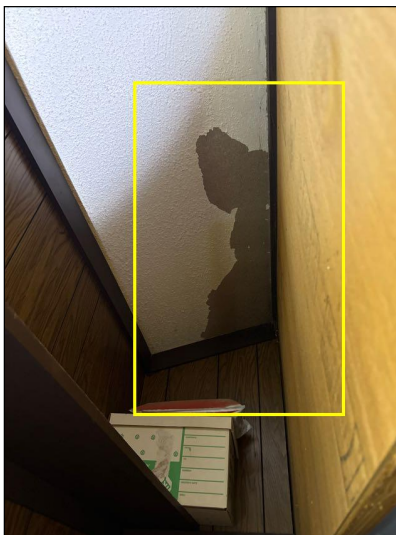
*Monitor:* Stains on the ceiling visible at the time of the inspection appeared to be the result of moisture intrusion.

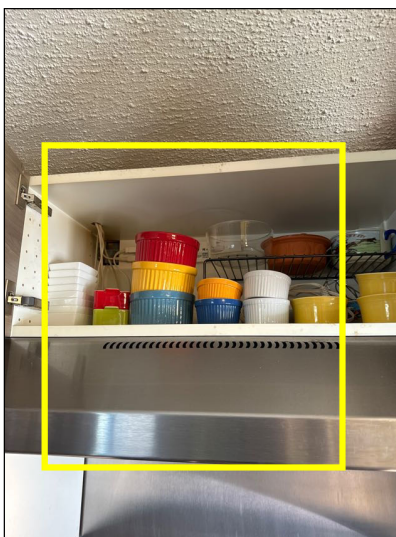
**Safety Improvement:** The exhaust fan is only re-circulating so no exhaust duct is vented to the exterior.

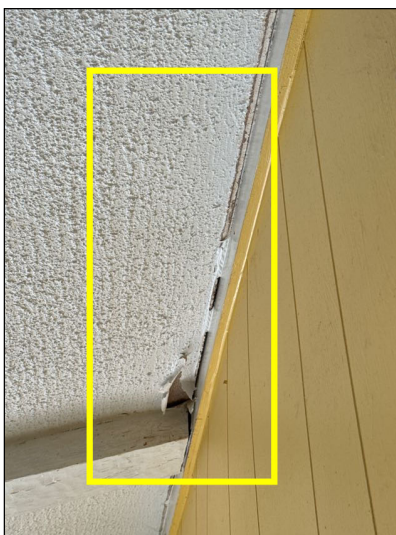
**Monitor:** Normal settlement cracking was visible in interior ceiling of the home at the time of the inspection.

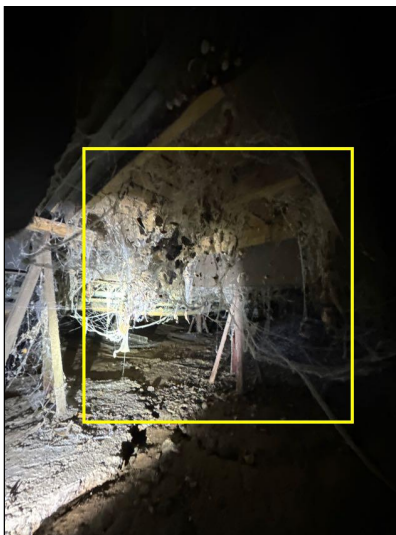
The dryer exhaust duct terminated in the crawlspace.

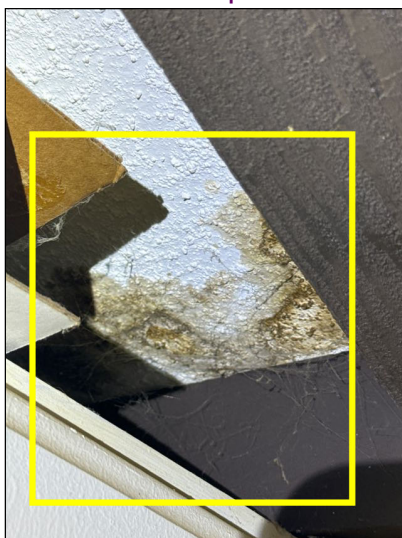
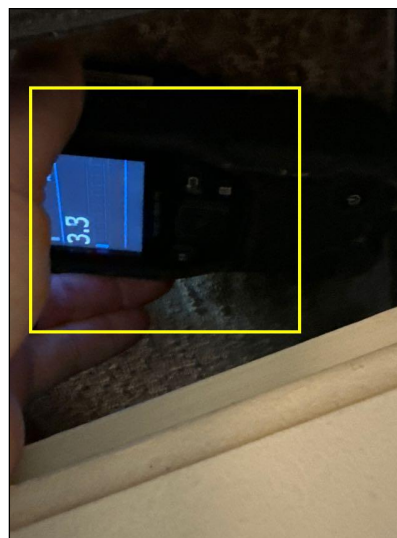
**Monitor:** Stains on the ceiling visible at the time of the inspection appeared to be the result of moisture intrusion.

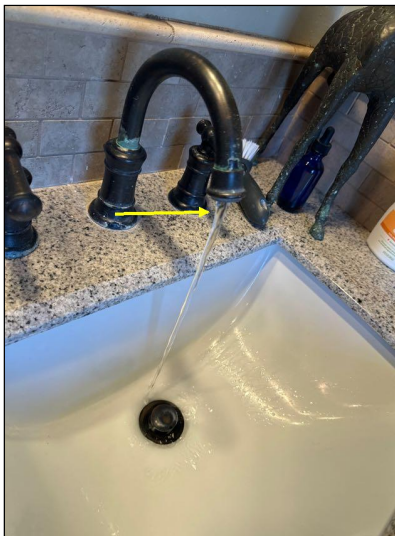
A plumbing fixture in the bathroom sink exhibited inadequate flow.

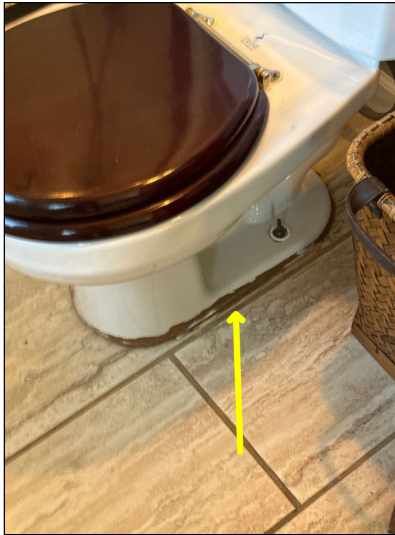
In this bathroom, the toilet was loose at the floor and should be re-attached by a qualified plumbing contractor.

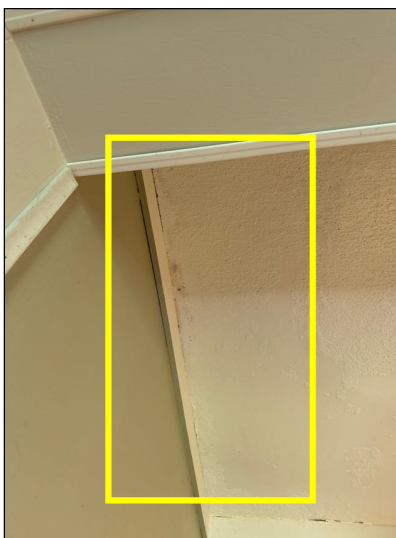
**Monitor:** Stains on the ceiling visible at the time of the inspection appeared to be the result of moisture intrusion.

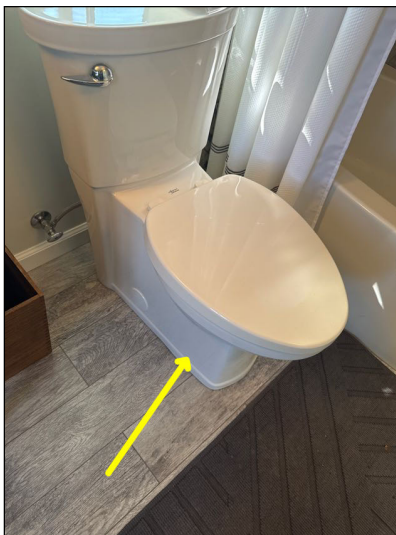
In this bathroom, the toilet was loose at the floor and should be re-attached by a qualified plumbing contractor.

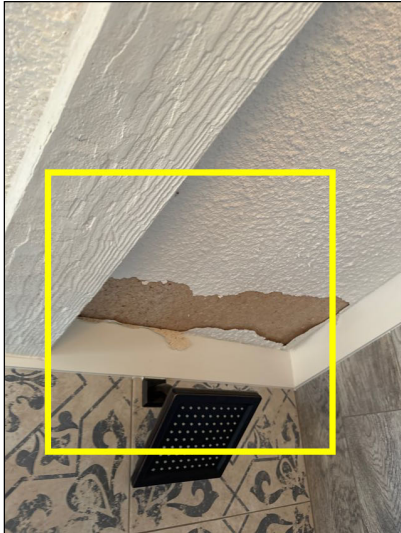
*Monitor:* Stains on the ceiling visible at the time of the inspection appeared to be the result of moisture intrusion.

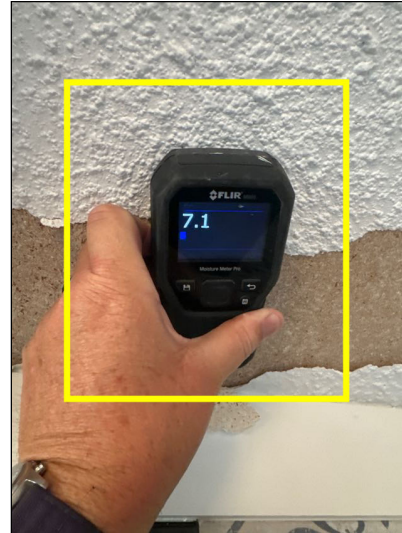
The moisture meter showed no elevated levels of moisture present in the stained areas at the time of the inspection (Normal moisture is considered between 5-12%)

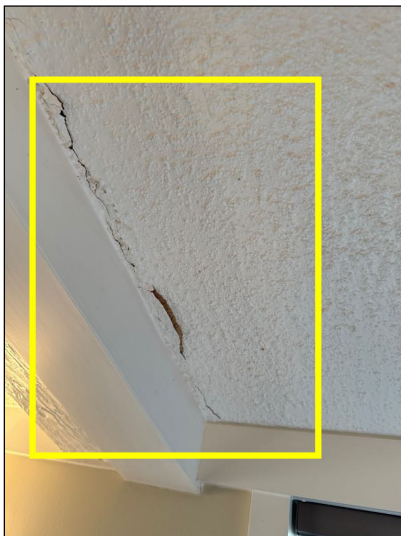
*Monitor:* Stains on the ceiling visible at the time of the inspection appeared to be the result of moisture intrusion.

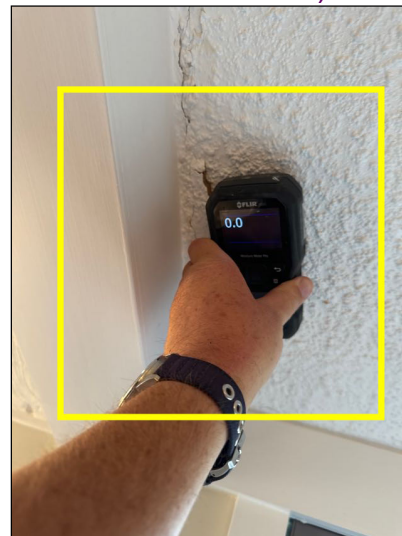
The moisture meter showed no elevated levels of moisture present in the stained areas at the time of the inspection (Normal moisture is considered between 5-12%)

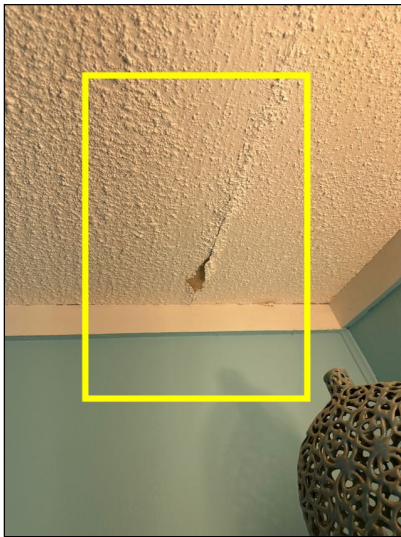
**Monitor:** Stains on the ceiling visible at the time of the inspection appeared to be the result of moisture intrusion.

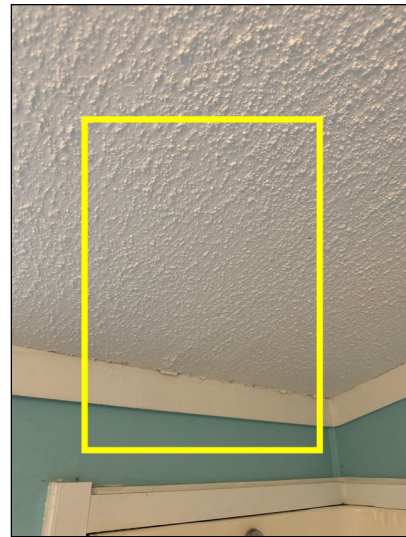
**Monitor:** Stains on the ceiling visible at the time of the inspection appeared to be the result of moisture intrusion.

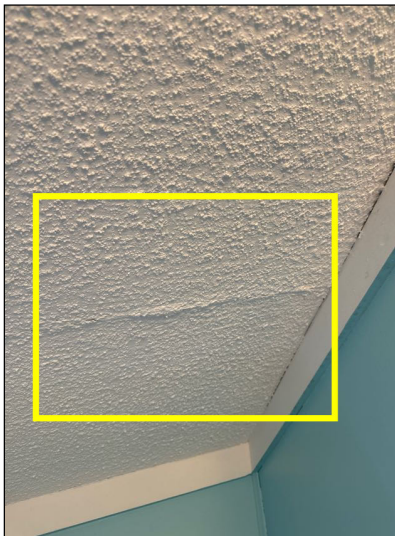
**Monitor:** Stains on the ceiling visible at the time of the inspection appeared to be the result of moisture intrusion.

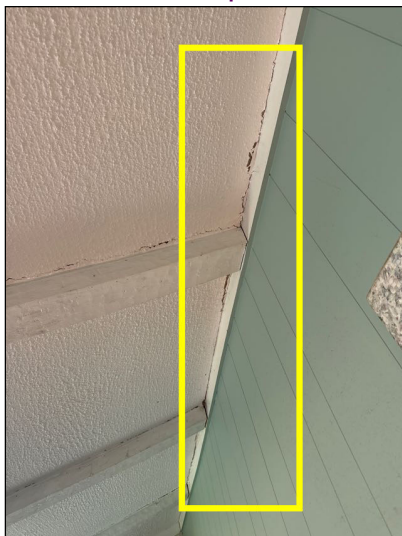
**Monitor:** Normal settlement cracking was visible in interior ceiling of the home at the time of the inspection.

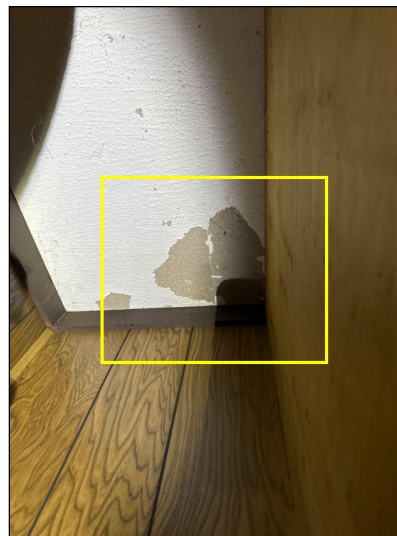
**Monitor:** Stains on the ceiling visible at the time of the inspection appeared to be the result of moisture intrusion.

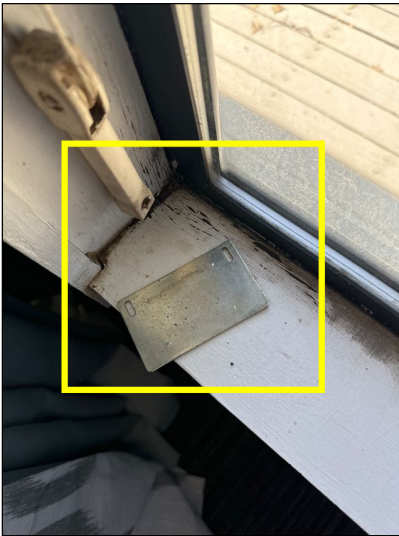
Windows sills in the home exhibited minor damage that appeared to be from moisture intrusion.

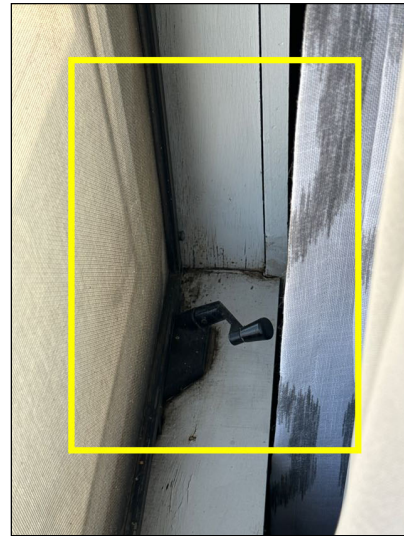
Windows sills in the home exhibited minor damage that appeared to be from moisture intrusion.

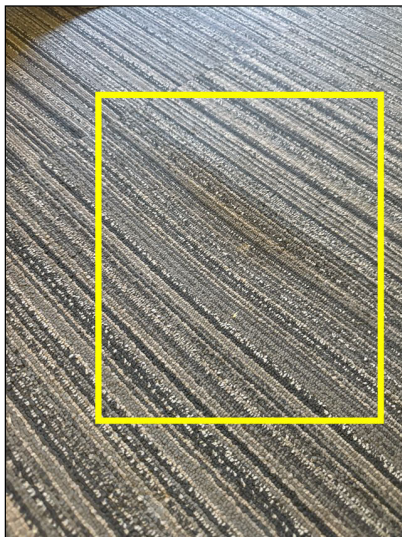
**Monitor:** The home had area(s) of uneven floor that may be caused by settlement or damaged sub flooring.

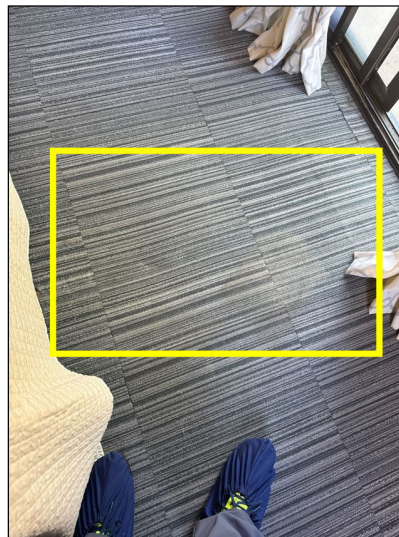
**Monitor:** The home had area(s) of uneven floor that may be caused by settlement or damaged sub flooring.

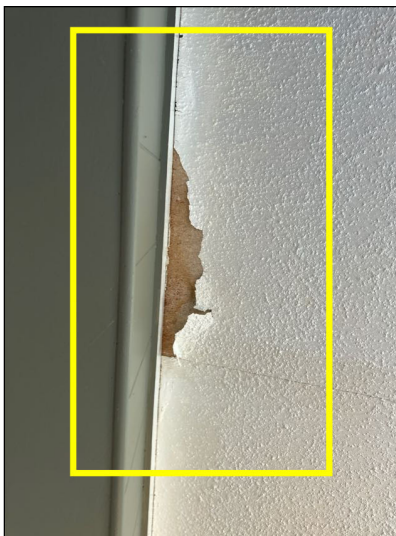
**Monitor:** Stains on the ceiling visible at the time of the inspection appeared to be the result of moisture intrusion.

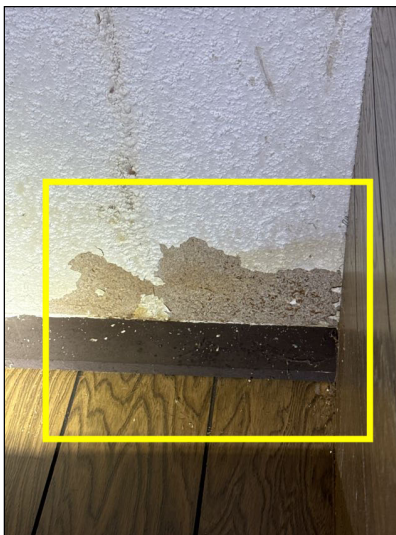
**Monitor:** Stains on the ceiling visible at the time of the inspection appeared to be the result of moisture intrusion.

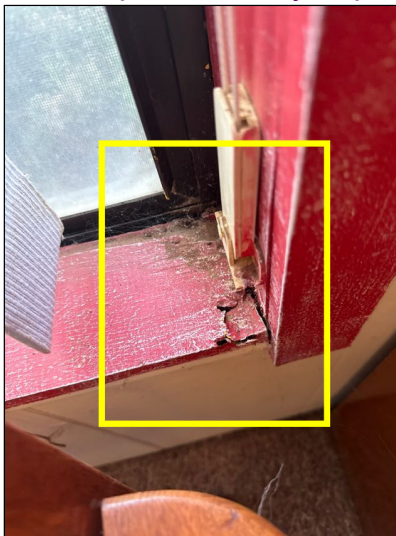
Windows sills in the home exhibited moderate damage that appeared to be from moisture intrusion.
